L31 Altima (MY02-06) & A34 Maxima (Redacted - CBI)

Floor Pan Corrosion Issue Up-date and Draft direction of campaign

**2013/9/19
NNA FQA**

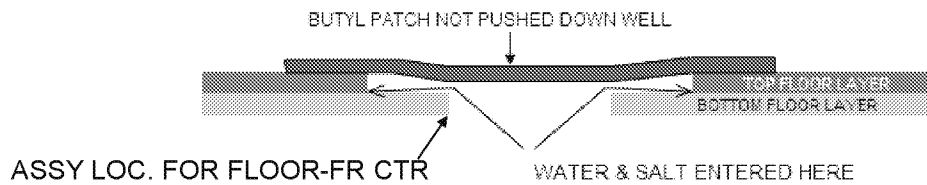
Butyl patch on the Front Floor was not pressed down sufficiently during the manufacturing process, allowing water to wick between the two floor panels.

Water and salt can enter between the floor panels through a hole in the floor assembly. And then, the corrosion was created between panels.

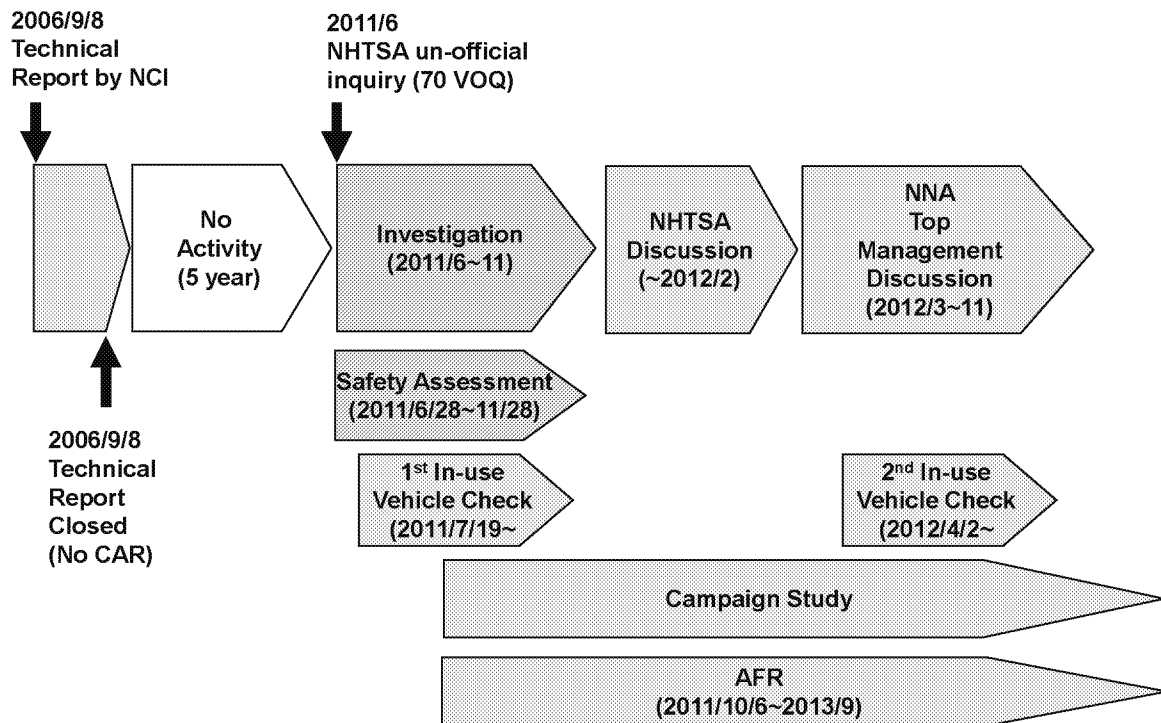
History of this concern

→ There is no clear instruction of double layer panel.

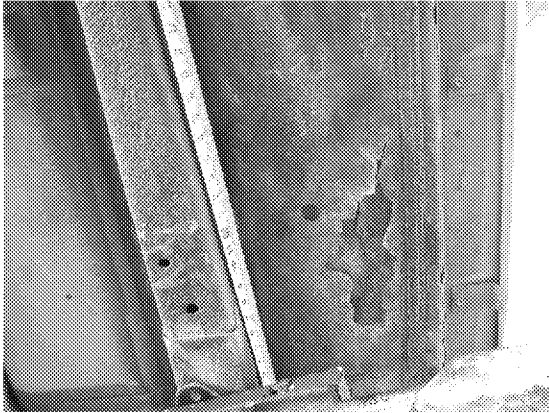
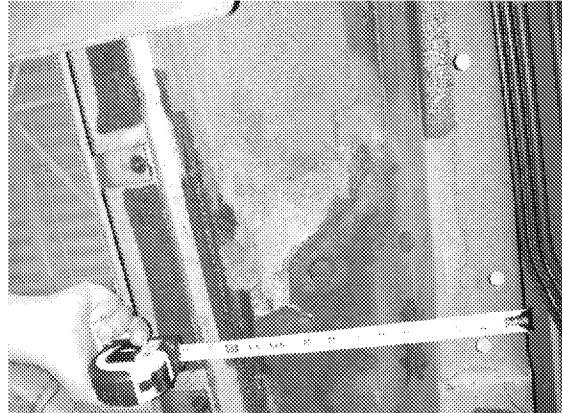
Rust and/or corrosion on the floor pan of the vehicle. Incident vehicles show rusted areas on both LH and RH sides of floor pan.

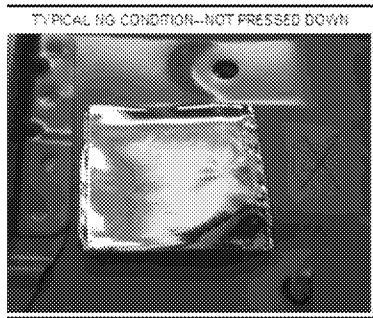
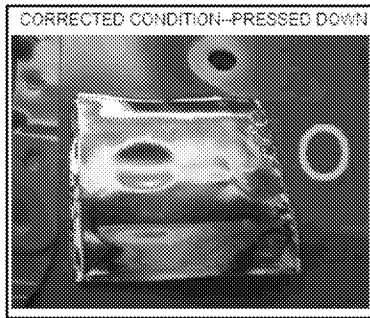
<Parts Condition Comparison>

Water and salt can enter between floor panels through a hole in the floor assembly. This is due to an insufficient seal condition for the butyl patch on the inner side of the floor assembly.
